## **Stream Channel Stability and Channel Evolution in a Rapidly Urbanizing, Ridge-and-Valley Watershed, Beaver Creek, Knox County, Tennessee**

Francis Bartholomew Keaney  
*University of Tennessee - Knoxville*

Keaney, Francis Bartholomew, "Stream Channel Stability and Channel Evolution in a Rapidly Urbanizing, Ridge-and-Valley Watershed, Beaver Creek, Knox County, Tennessee. " Master's Thesis, University of Tennessee, 2009.

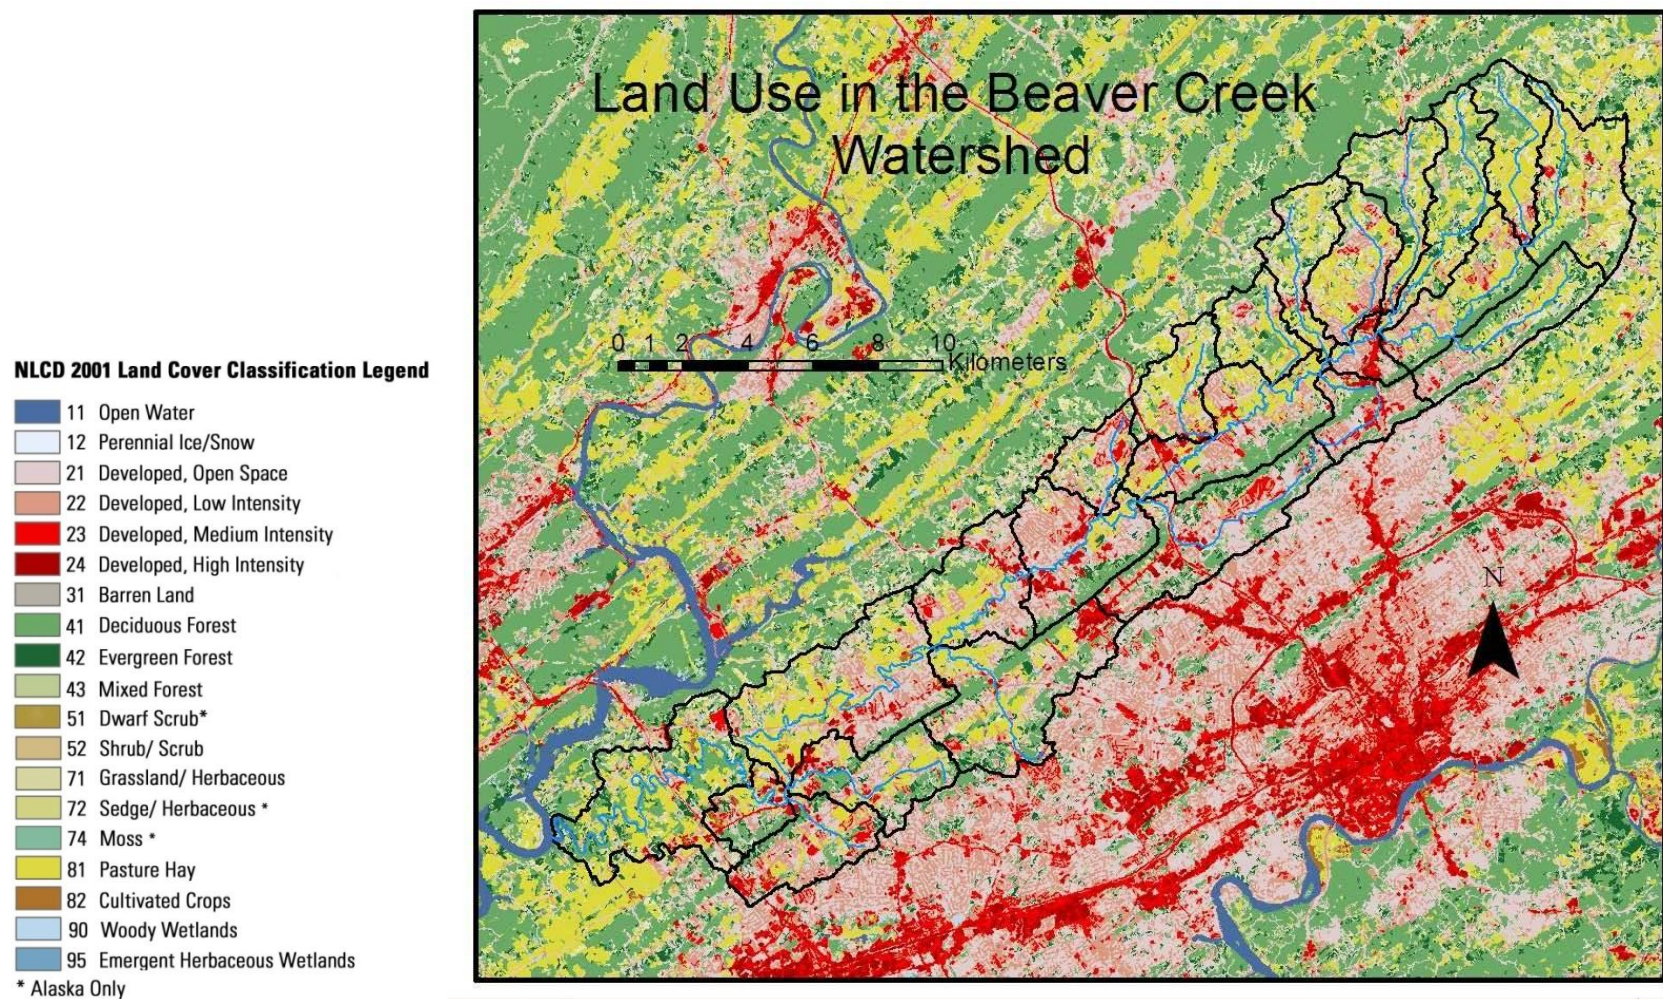
Figure 1 - 2001 NLCD Land Cover in Beaver Creek Watershed and Surrounding Areas

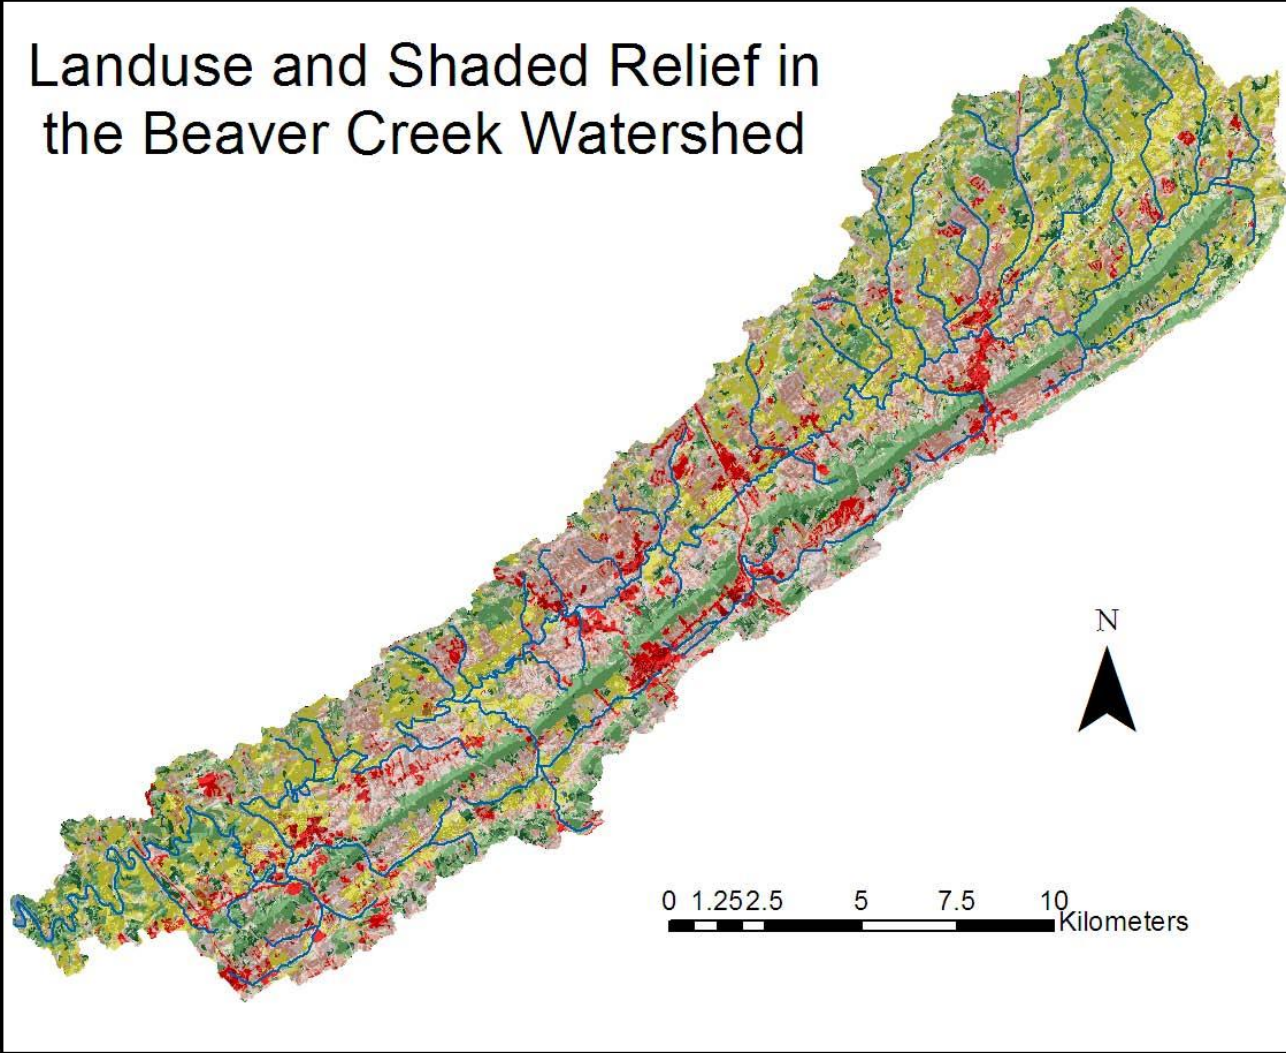
Figure 2 - 2001 NLCD Land Use and Shaded Relief in the Beaver Creek Watershed

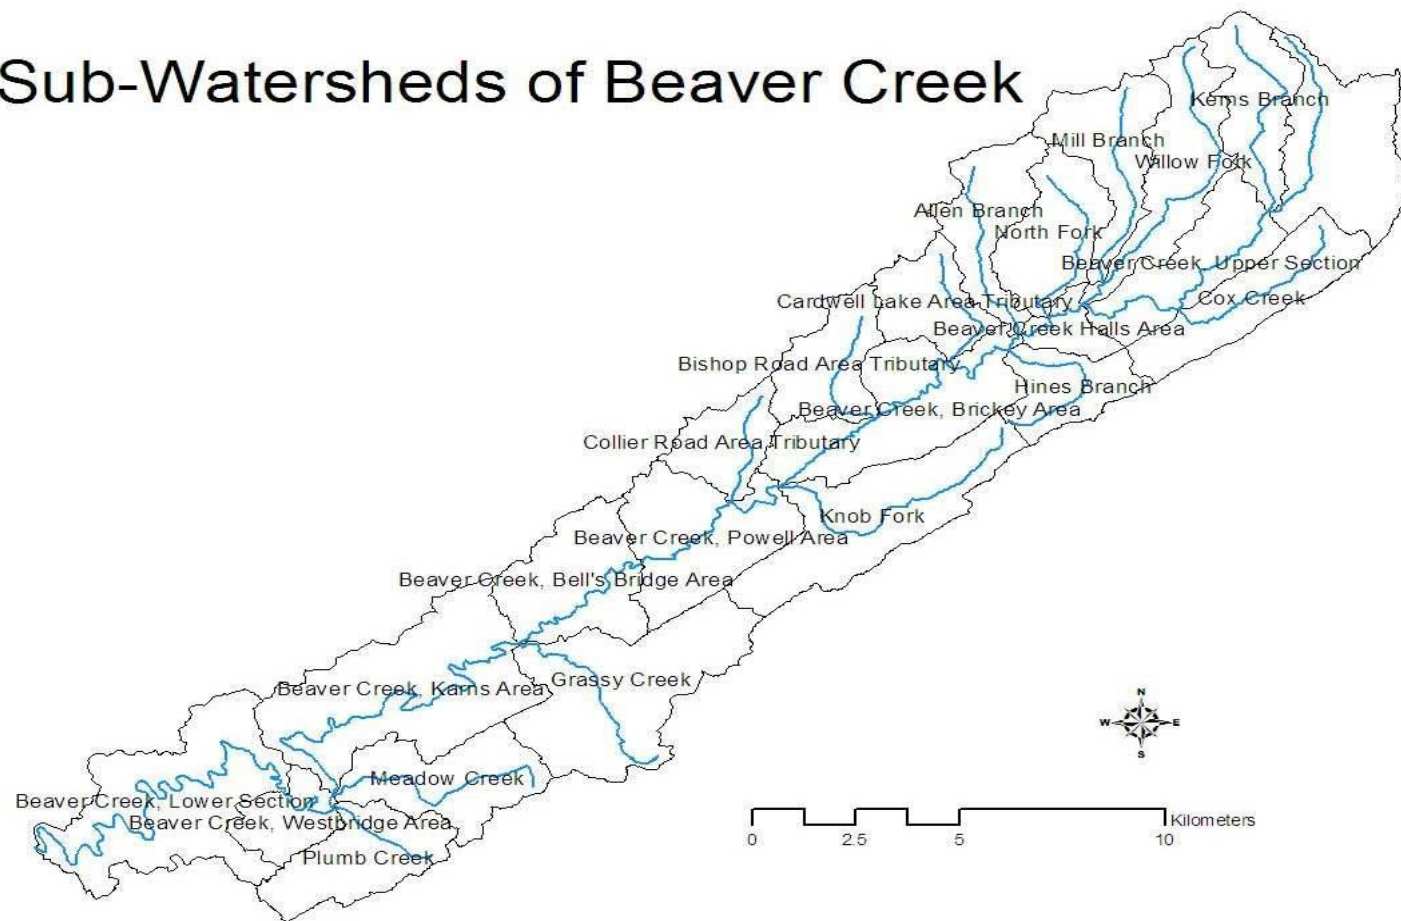
Figure 3 - Sub-Watersheds of the Beaver Creek Watershed

For the purposes of this study, the watershed was divided into the sub-watersheds that drained the tributary streams. This allowed for the level of development in a variety of small catchments to be analyzed separately. These sub-watersheds are shown in the context of the entire Beaver Creek watershed in Figure 3.

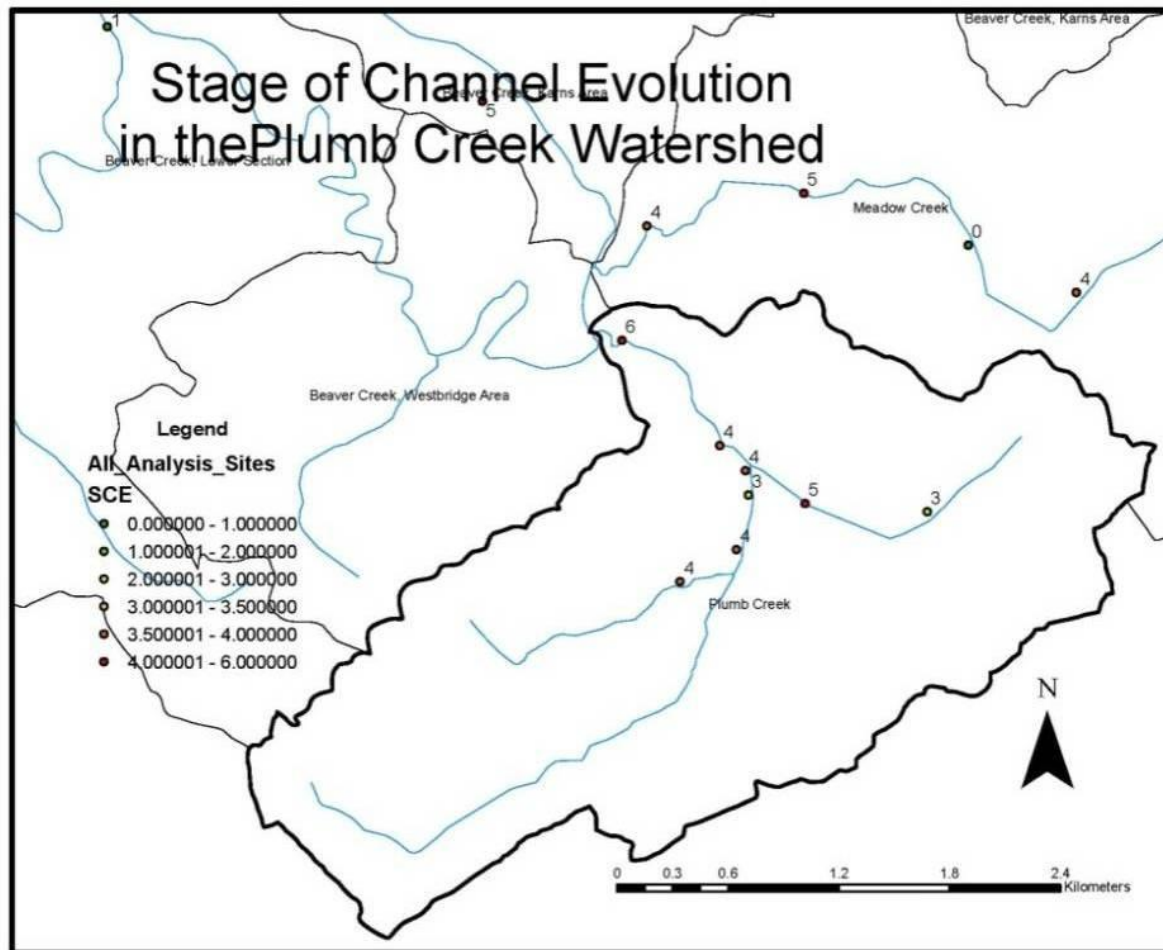
Figure 4 - Stages of Channel Evolution in the Plumb Creek Watershed

As shown in Tables 1 and 2 and Figure 4, there was not apparent that the stage of channel evolution at any given site was responding to any particular area of maximum disturbance, even though the sites were within 1 km of each other.

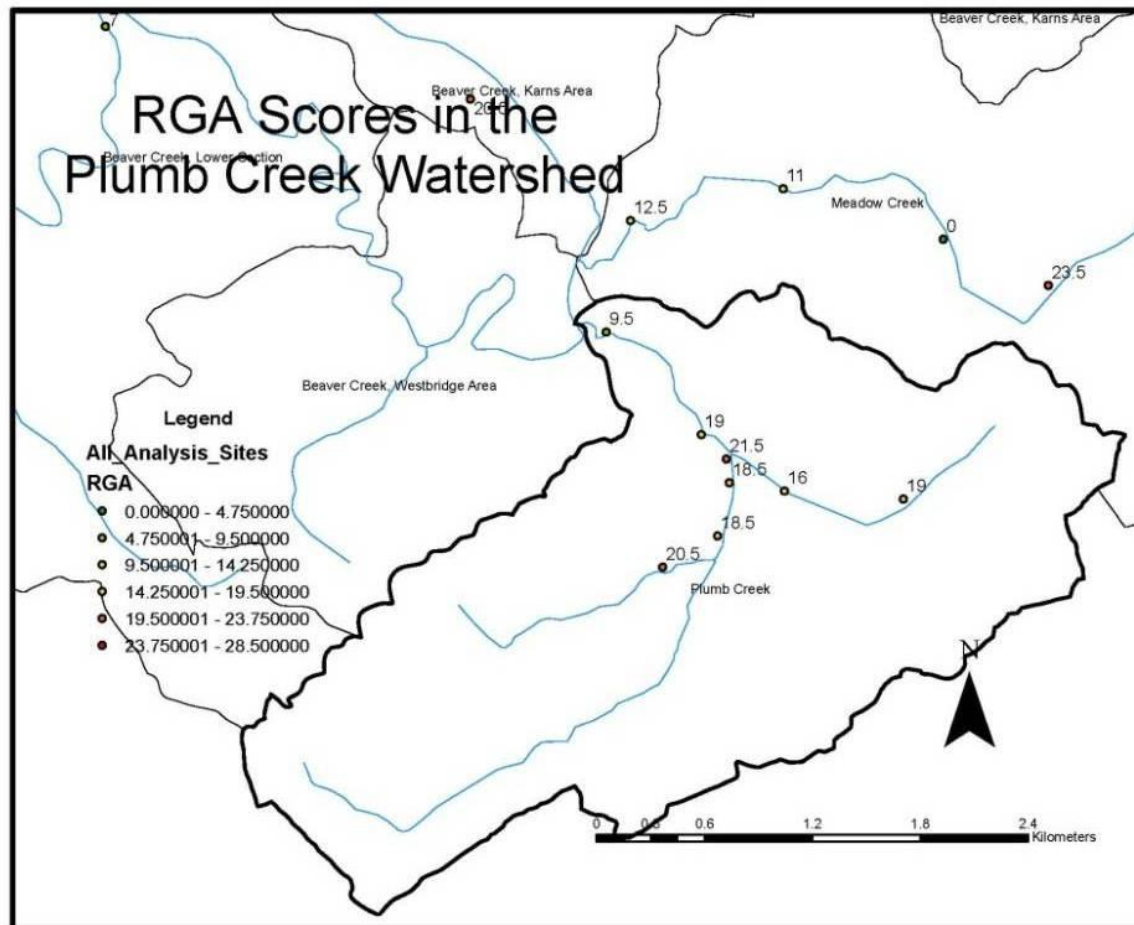
Figure 5 - RGA Scores in the Plumb Creek Watershed

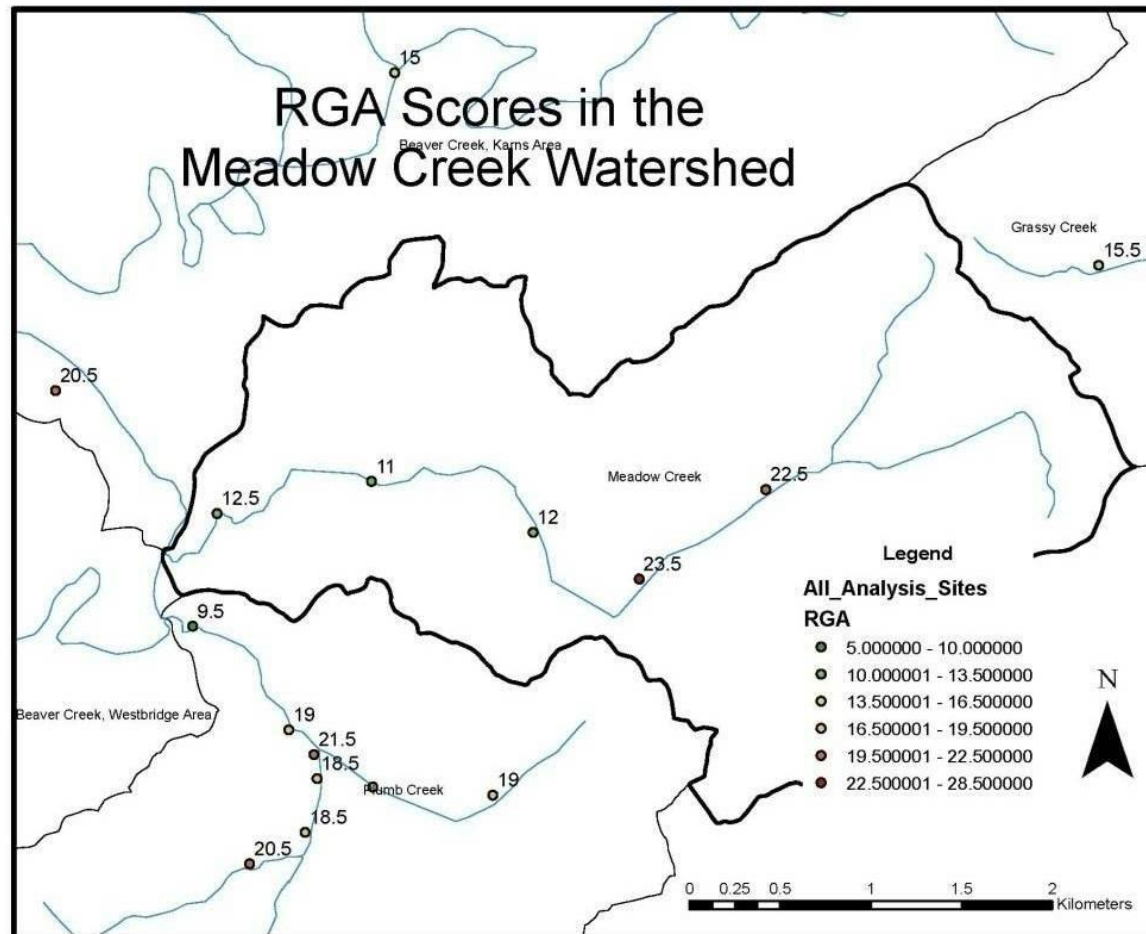
Figure 6 - RGA Scores in the Meadow Creek Watershed

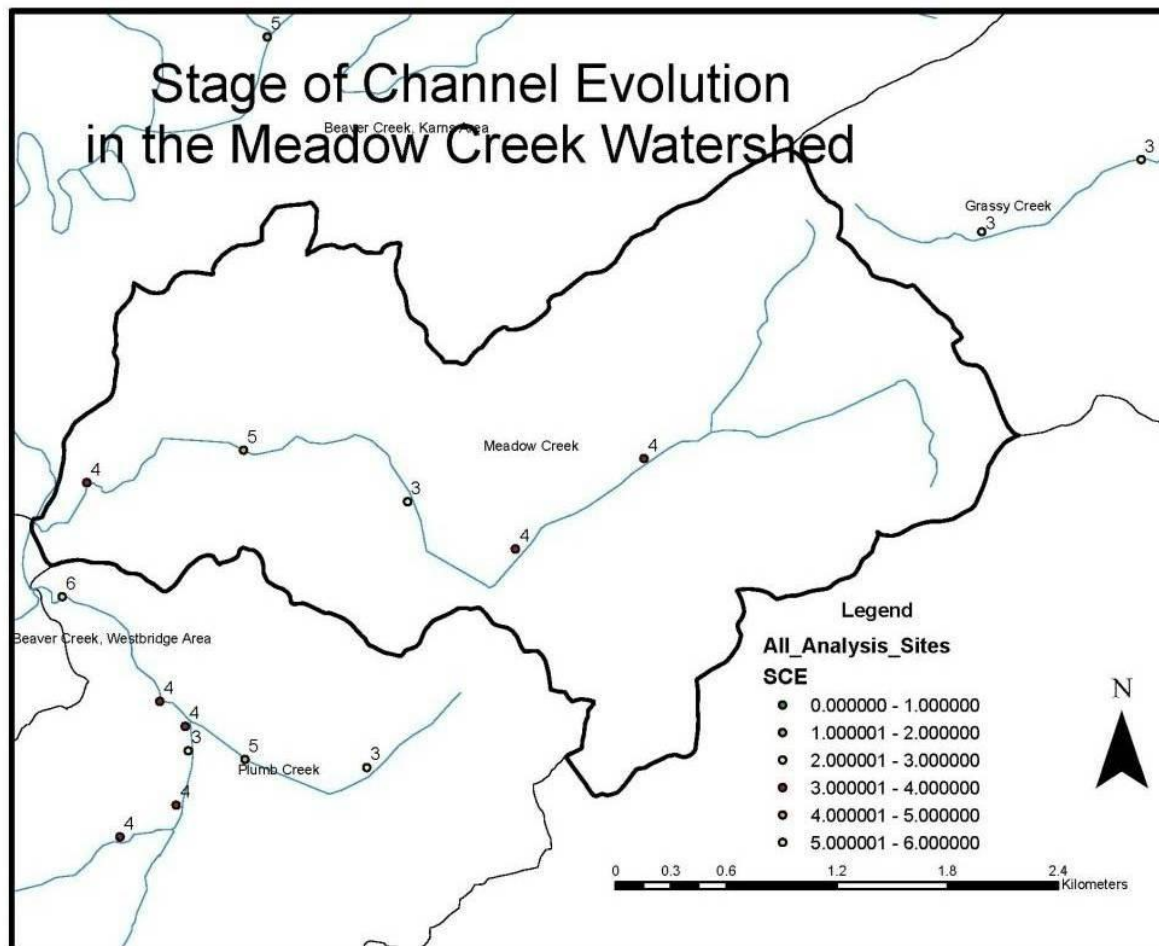
Figure 7 - Stages of Channel Evolution in the Meadow Creek Watershed

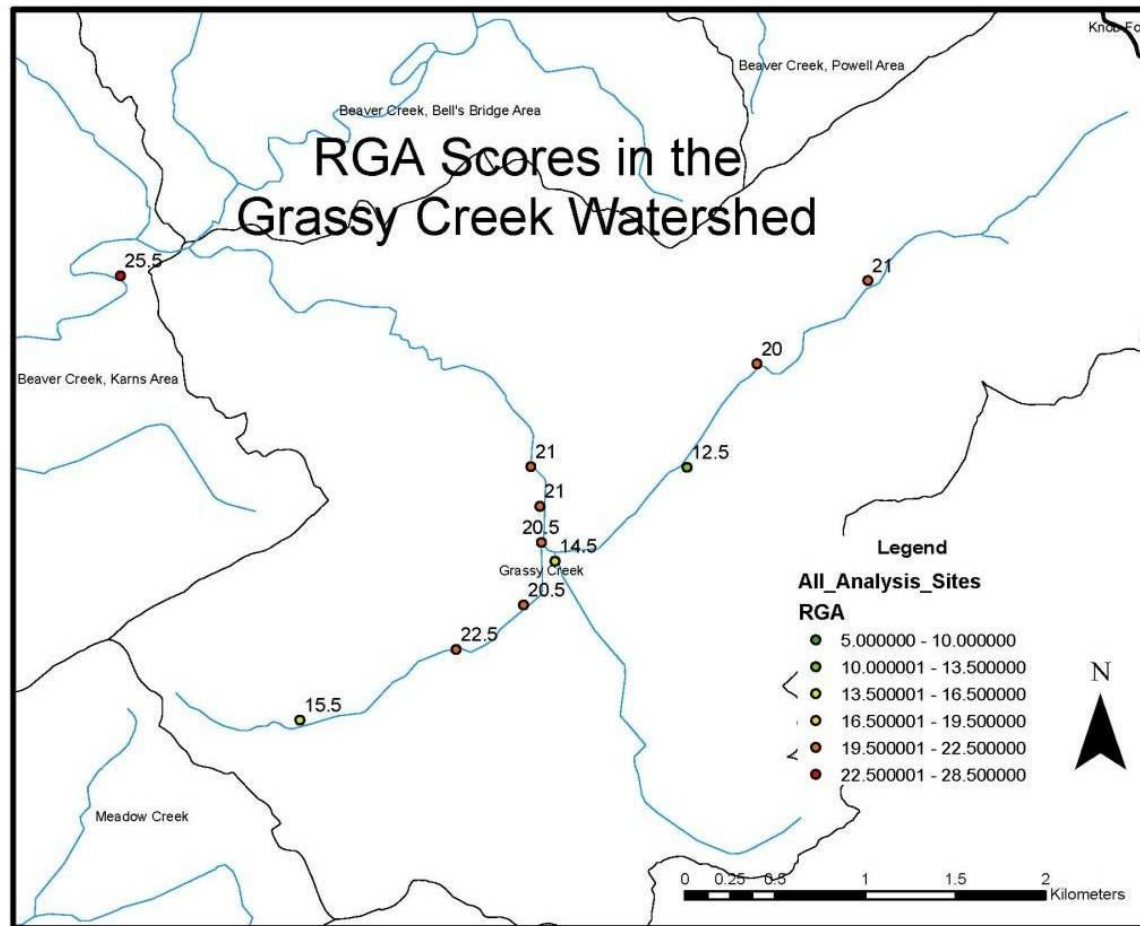
Figure 8 - RGA Scores in the Grassy Creek Watershed

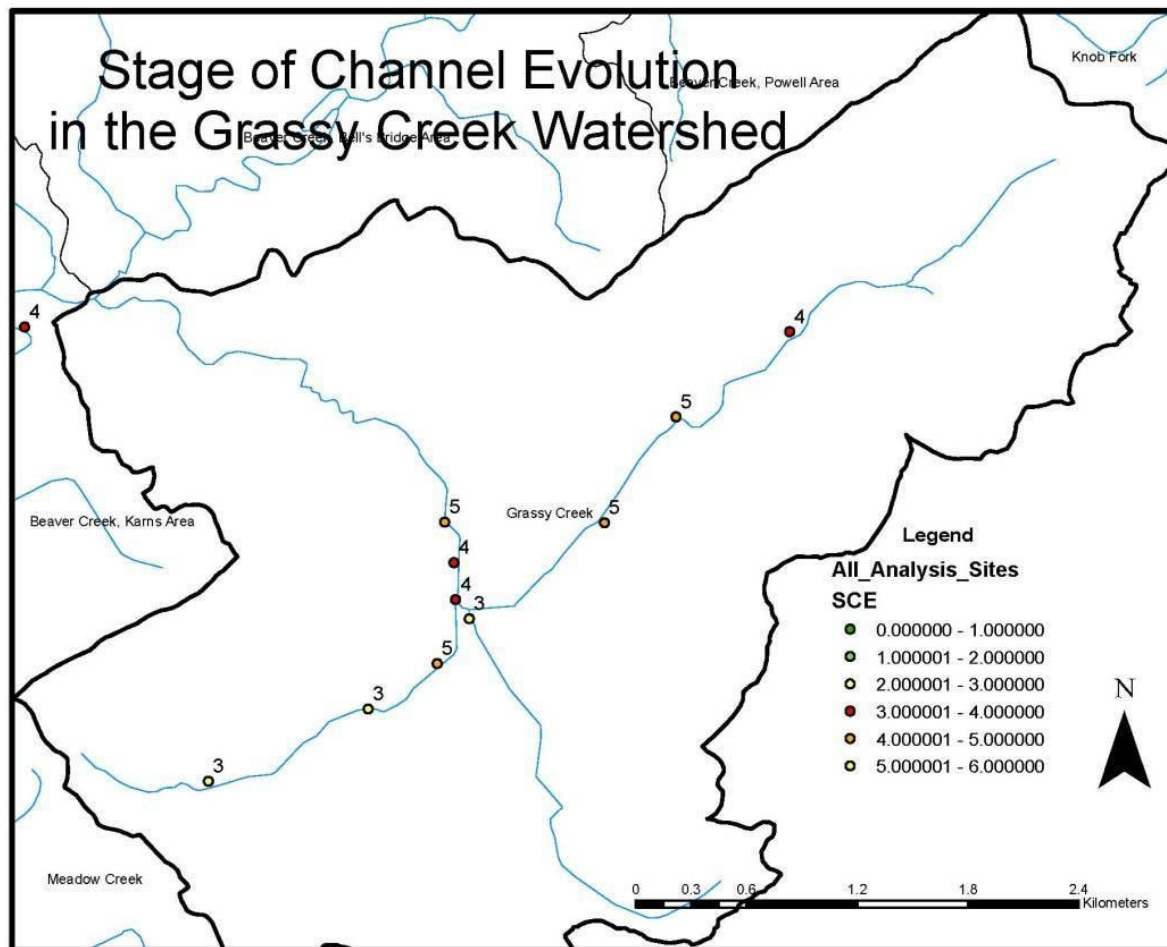
Figure 9 - Stages of Channel Evolution in the Grassy Creek Watershe

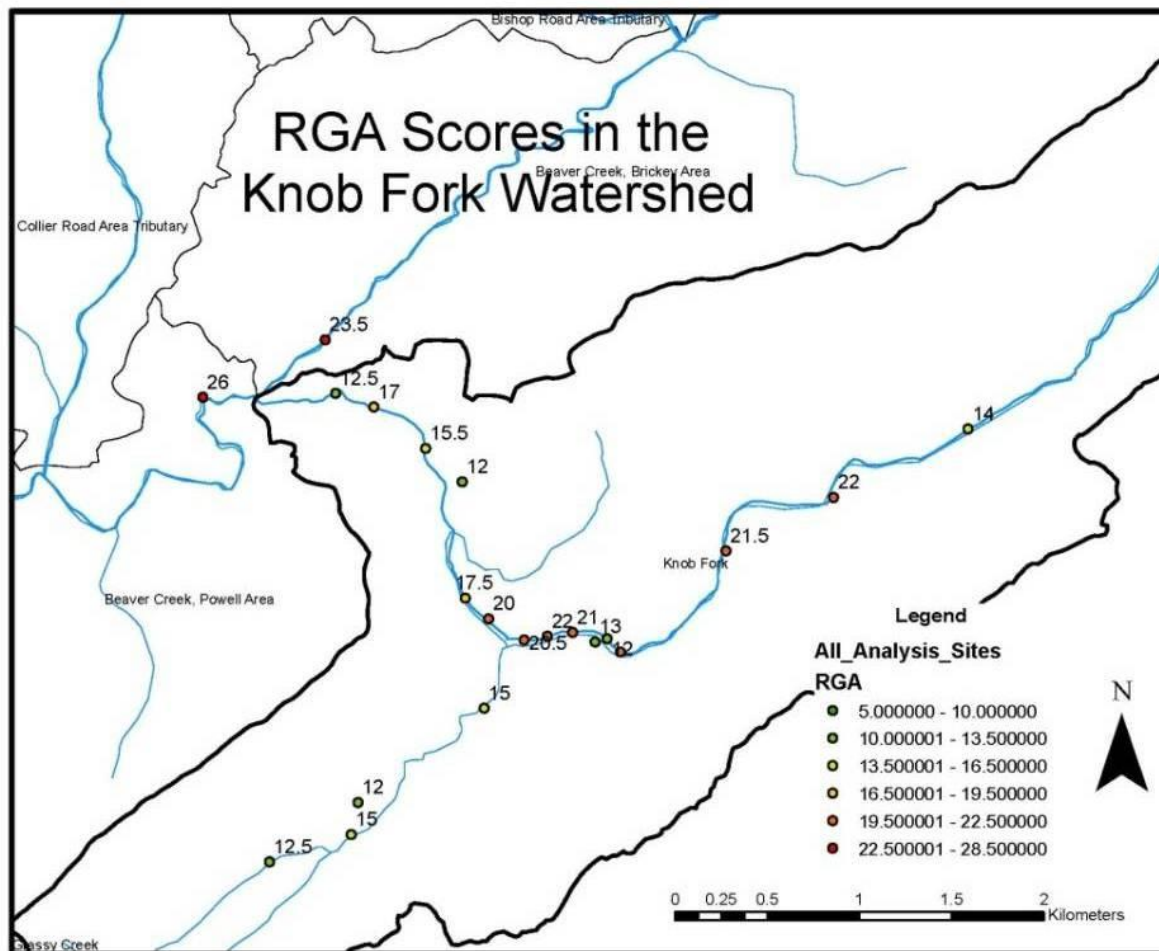
Figure 10 - RGA Scores in the Knob Fork Watershed

Eight sites were fully assessed in the Knob Fork watershed. Five sites were on Knob Fork itself, and three were located on its major tributary, Haw Branch. Progressing upstream, they were Site 4, Site 3, Site 0, Site 1, and Site 2 on Knob Fork itself, and Site 58, Site 60 and Site 59 on Haw Branch. In addition, eleven sites were assessed with the RGA, but no slope or pebble count measurements were taken. These sites are marked with letter identifiers, complete sites are marked with numbered identifiers. The Knob Fork watershed study area was found to be 59.62% developed, have 18.68% of its area covered by impervious surfaces, and remain 36.23% forested. These results place the Knob Fork watershed in the High Development category. Figure 10 shows the spatial relationship of the Stage of Channel Evolution in the watershed, and Figure 11 shows the RGA scores at each site.

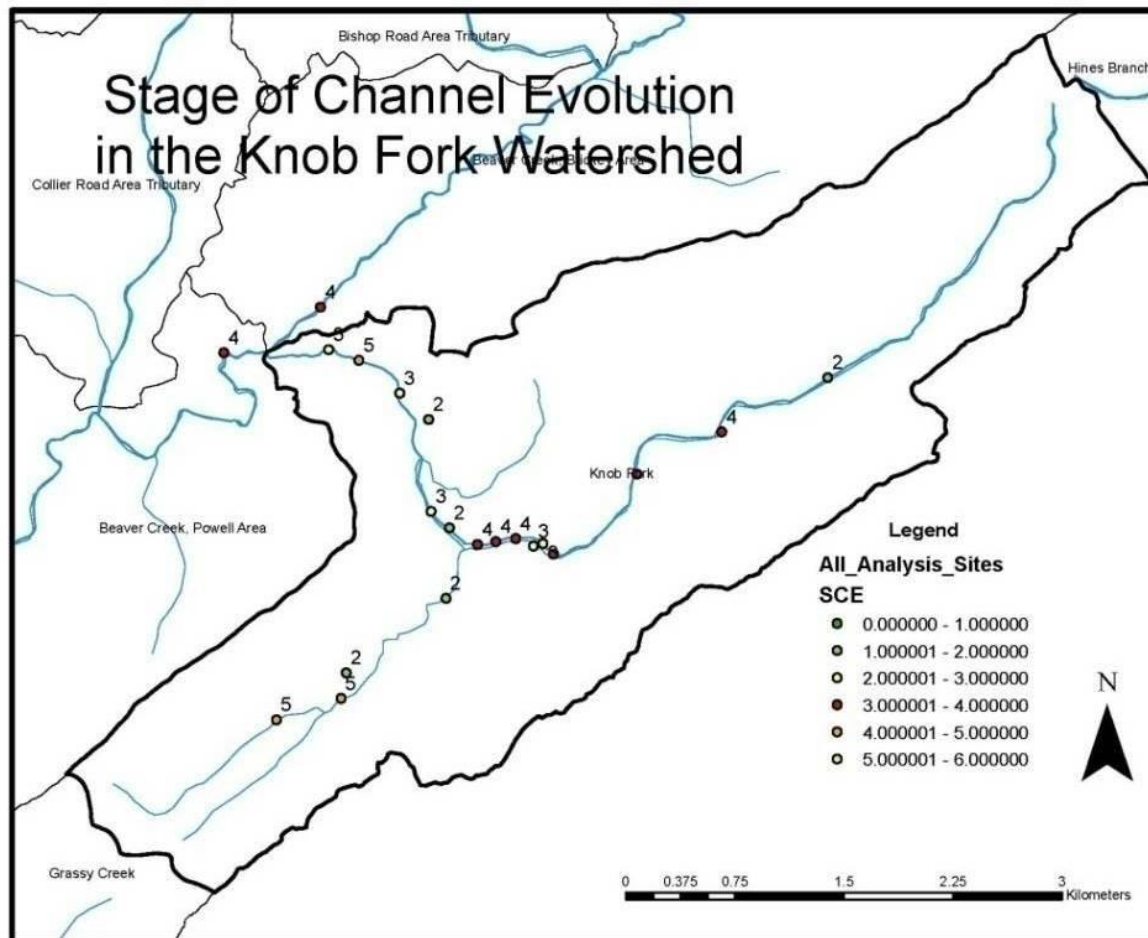
Figure 11 - Stages of Channel Evolution in the Knob Fork Watershed

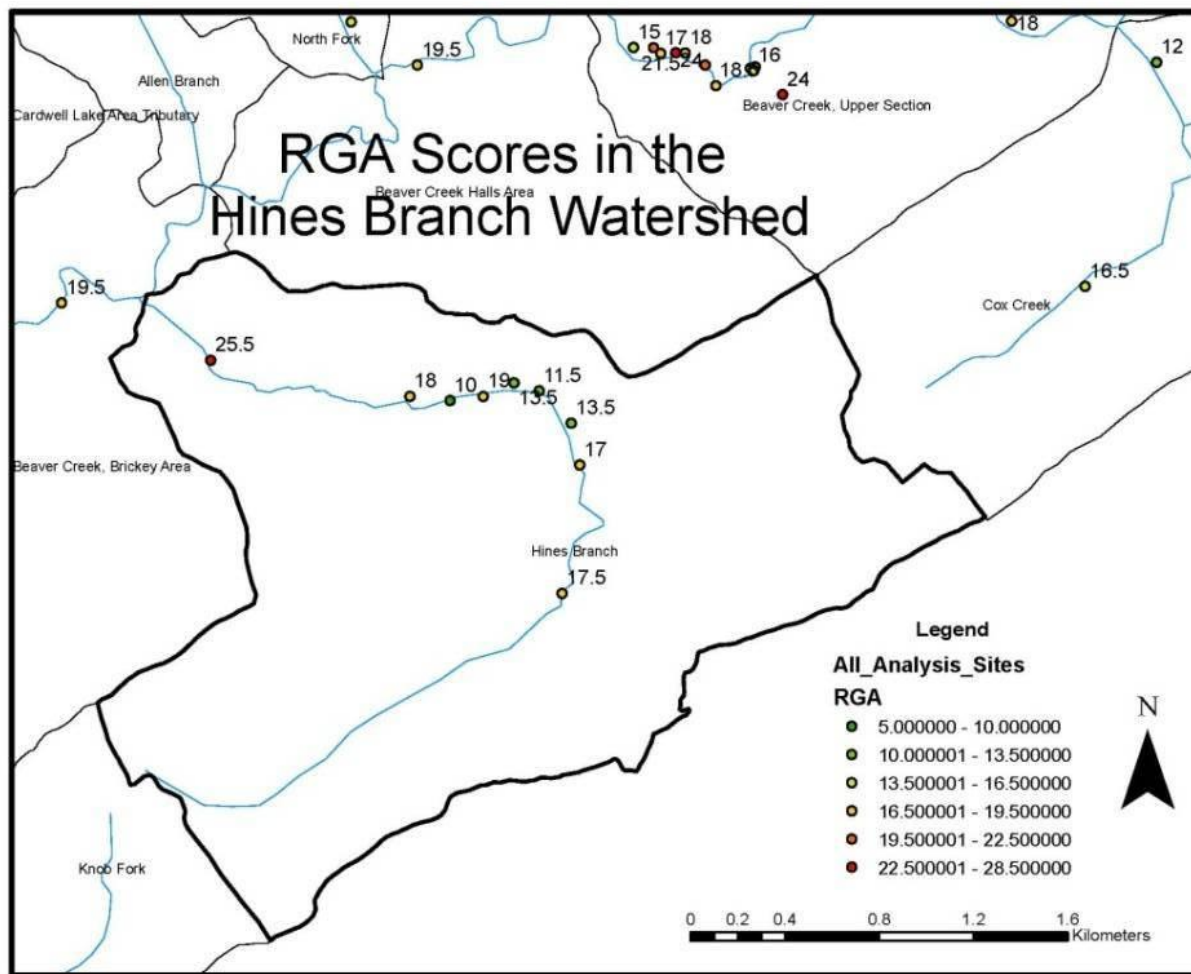
Figure 12 - RGA Scores in the Hines Branch Watershed

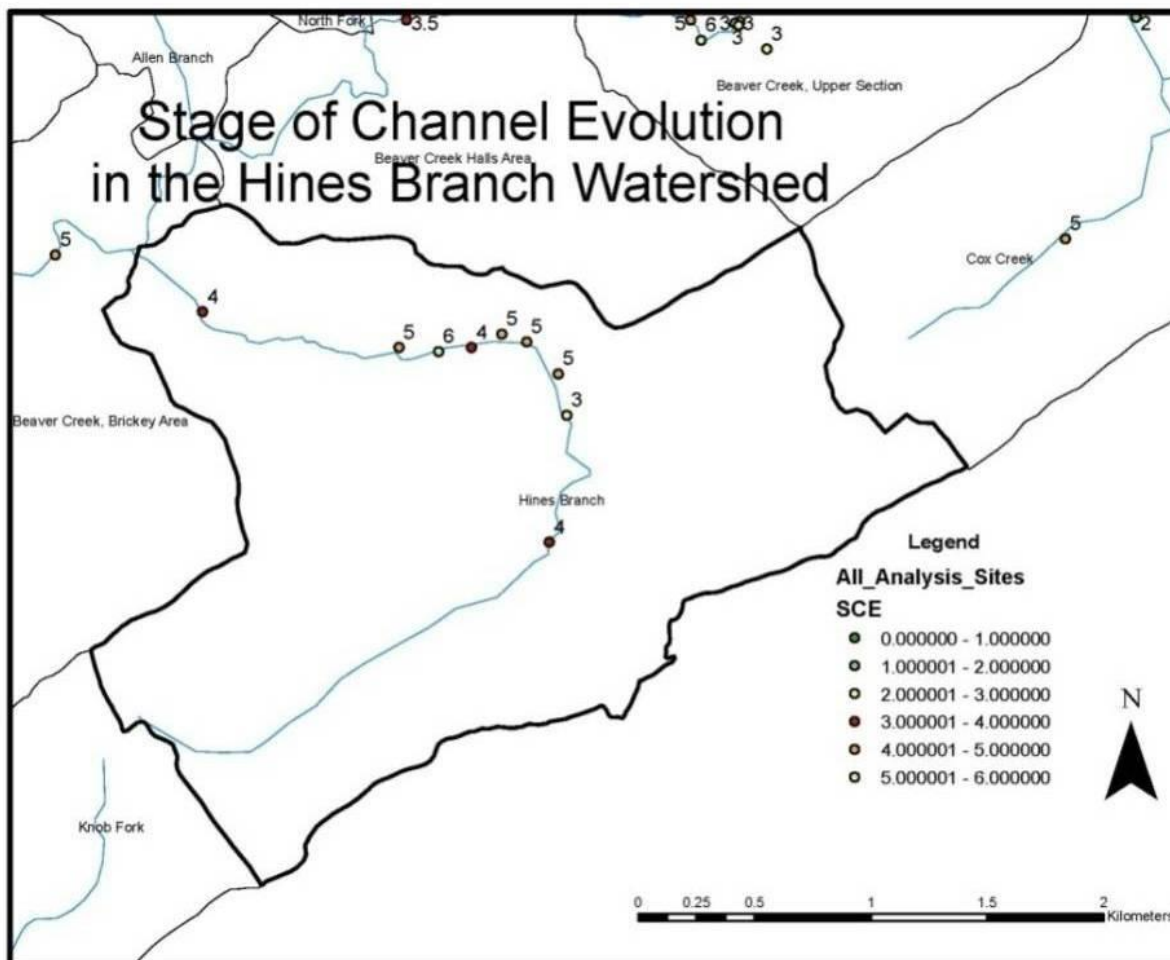
Figure 13- Stages of Channel Evolution in the Hines Branch Watershed

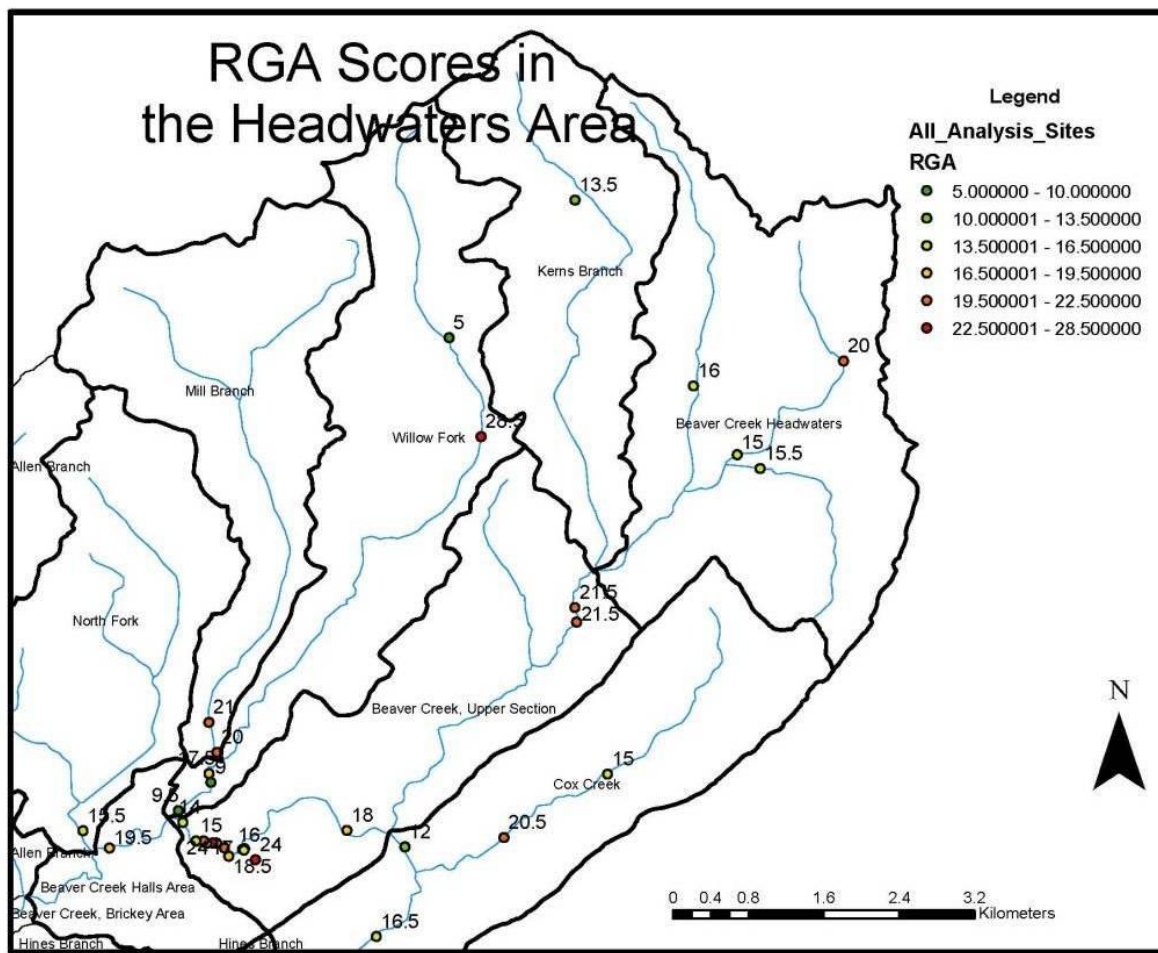
Figure 14 - RGA Scores in the Headwaters Watersheds

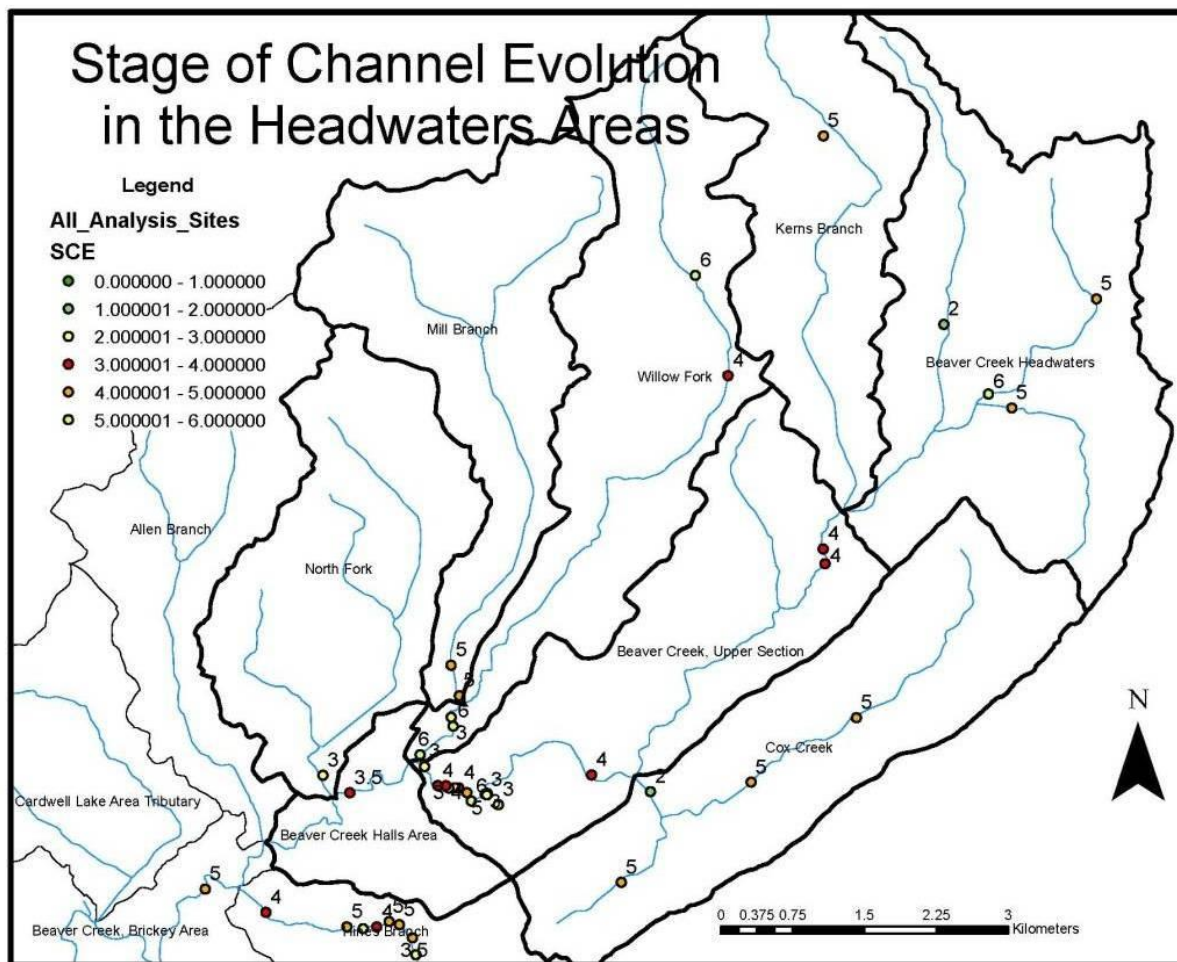
Figure 15 - Stages of Channel Evolution in the Headwaters Watersheds

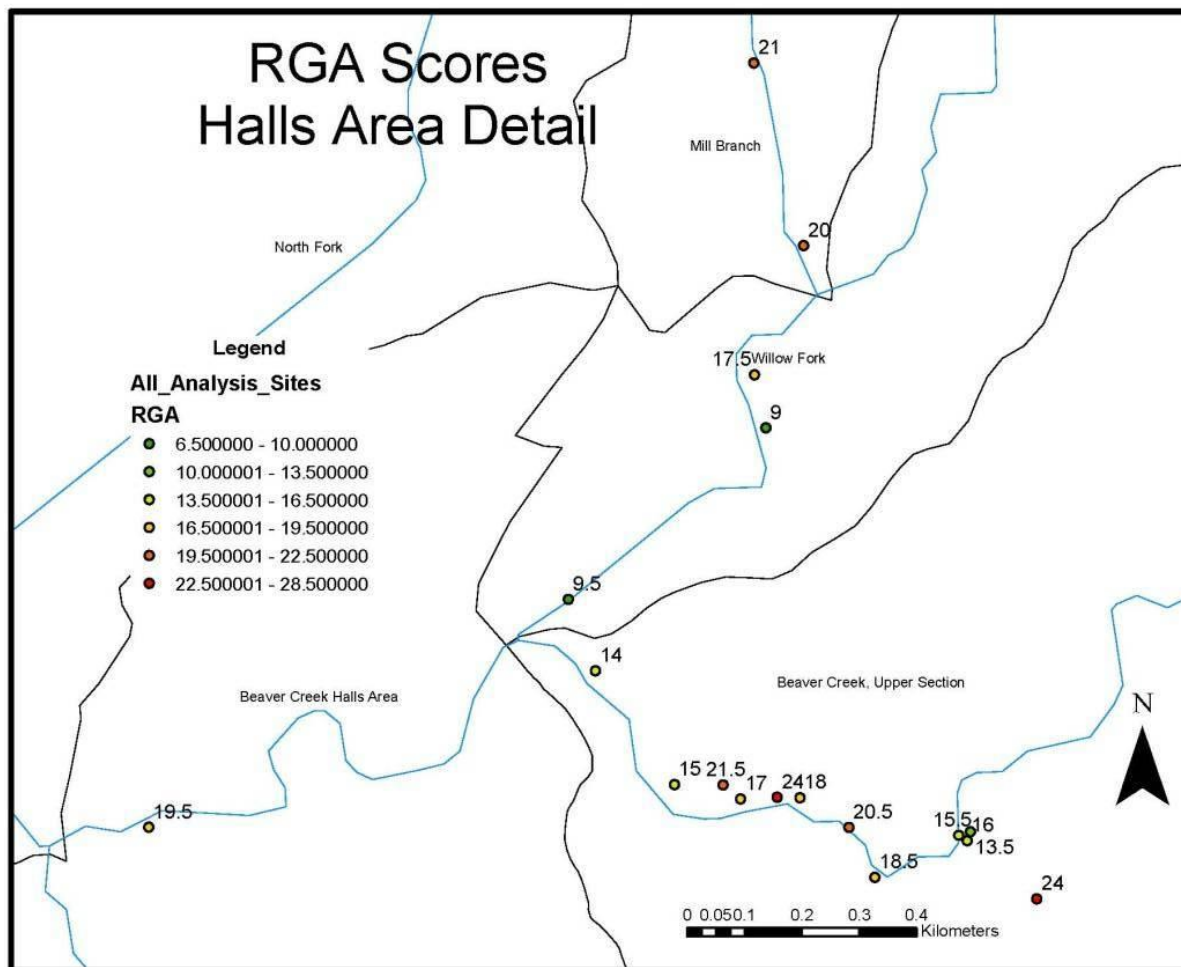
Figure 16 - Detail of RGA Scores in the Halls Area

Willow Fork, Lammie Branch, Kerns Branch, Cox Creek and a stretch of Beaver Creek. Fifteen sites were evaluated in this area, on several streams. Site 56 was on North Fork, Site 30 was on Willow Fork, Site 57 was on Mill Branch, Site 29 and Site 28 were on Lammie Branch, Site 61 was on Kerns Branch, Site 54 was on the southern branch of Cox Creek, Site 52 and Site 53 were on the northern branch of Cox Creek and on Beaver Creek itself were located Site 51, Site 34, Site 45, Site 37, Site 44, Site 38 and site 36. In the Headwaters study area, 22.04% of the land was found to be developed, 7.28% was covered by impervious surfaces and 31.84% of the land is forested. These watersheds were all grouped in the Low Development category. Figure 14 shows the spatial relationship of the Stage of Channel Evolution in the watershed, and Figure 15 shows the RGA scores at each site. Additionally, Figure 16 and Figure 17 show a detailed view of the assessment sites near Halls.

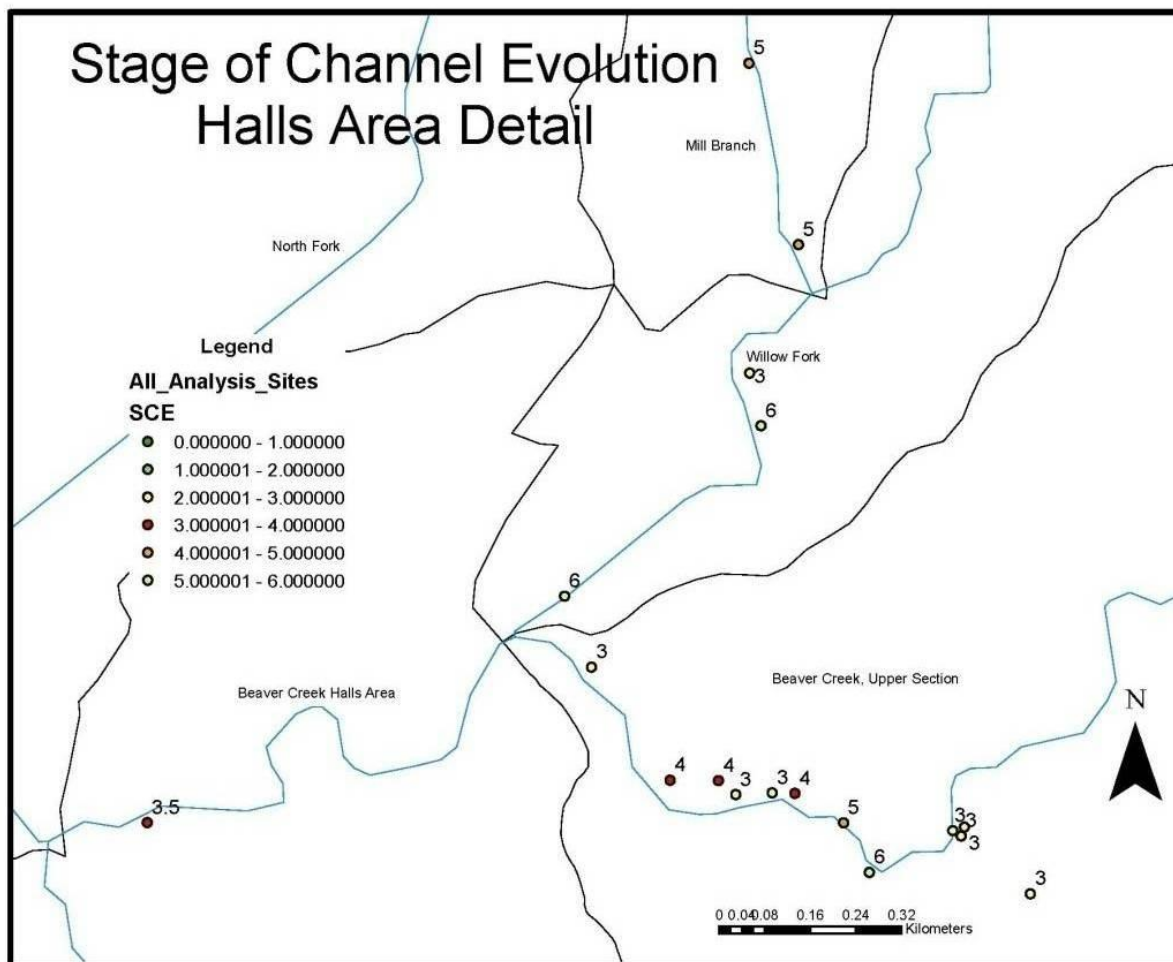
Figure 17 - Detail of the Stages of Channel Evolution in the Halls Area

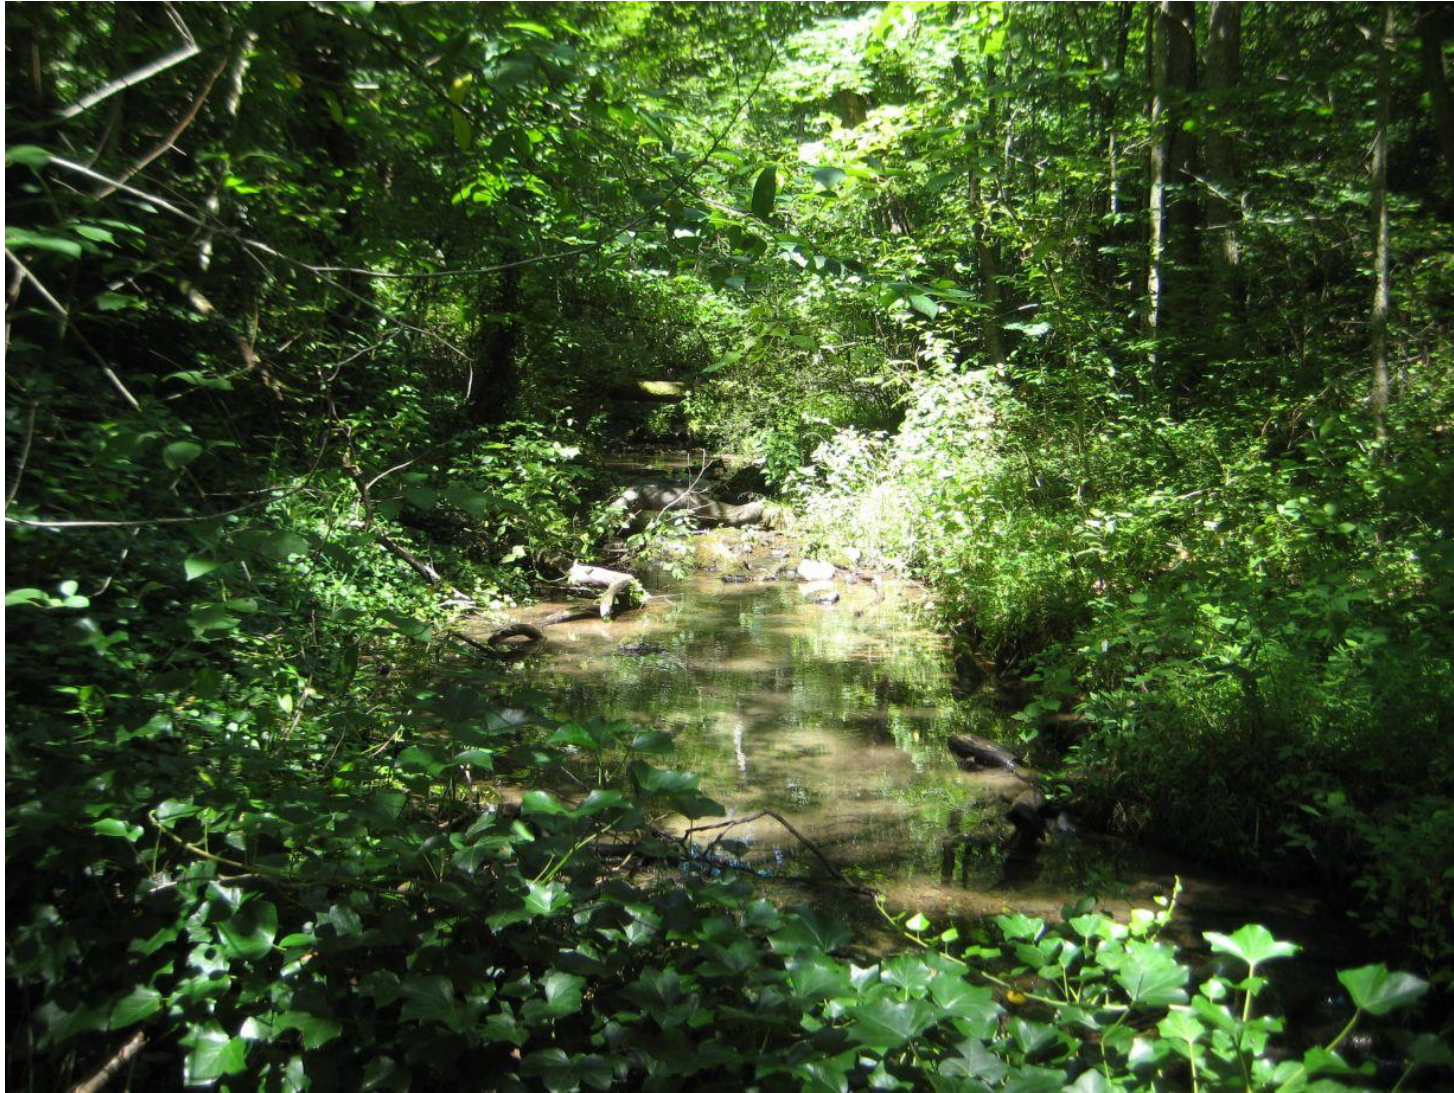
Figure 18 - Lammie Branch, Site 12. Channel Stability Index: 5

Figure 18 shows a site on Lammie Branch which received an RGA score of 5. It was located in a relatively undisturbed area, in a small valley in which the only apparent development was a single two lane road. Figure shows a site which received an RGA score of 28.5. It was also located on Lammie, about 1 kilometer downstream of the site shown in Figure 19, in a pasture used for cattle grazing. Just upstream of the site, the cows had access to the stream and had caused significant instability on the banks. This, coupled with the mostly silt bed material, lack of woody vegetation and lack of
